Subject: Annual Mining and Reclamation Report, Kennecott Eagle Minerals Company, Nonferrous Metallic Mineral Mining Permit (MP 01 2007), Eagle Mine

2011 Annual Mining and Reclamation Report

**Kennecott Eagle Minerals Company
Eagle Mine**

March 15, 2012

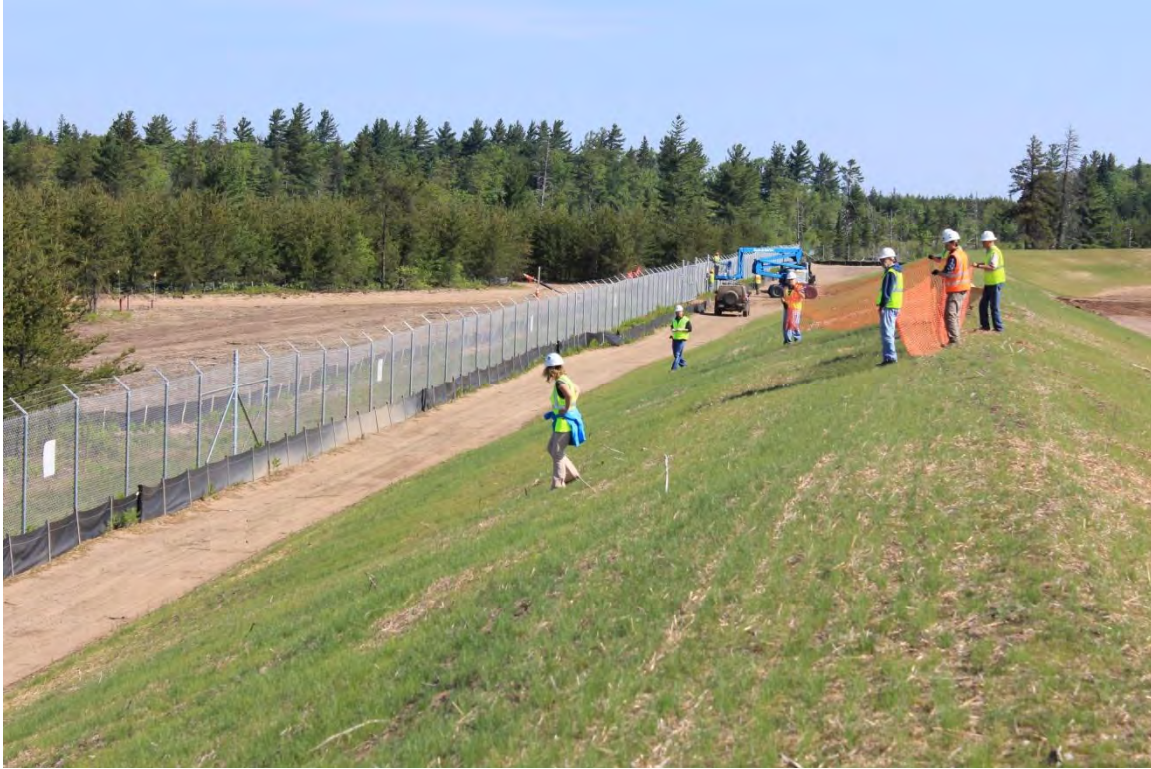
Best management practices implemented onsite include grading; roughening, seeding, and mulching of berms; silt fencing around the site perimeter and utility corridors; and water on travel ways to control dust. As construction activities conclude, any exposed soil is immediately seeded and mulched to encourage vegetative growth and reduce potential wind/water erosion. In addition, more permanent measures are being evaluated for implementation in 2012. These may include site grading, swales, and additional vegetative control measures.

Soil Berms and Stabilization, June 2011

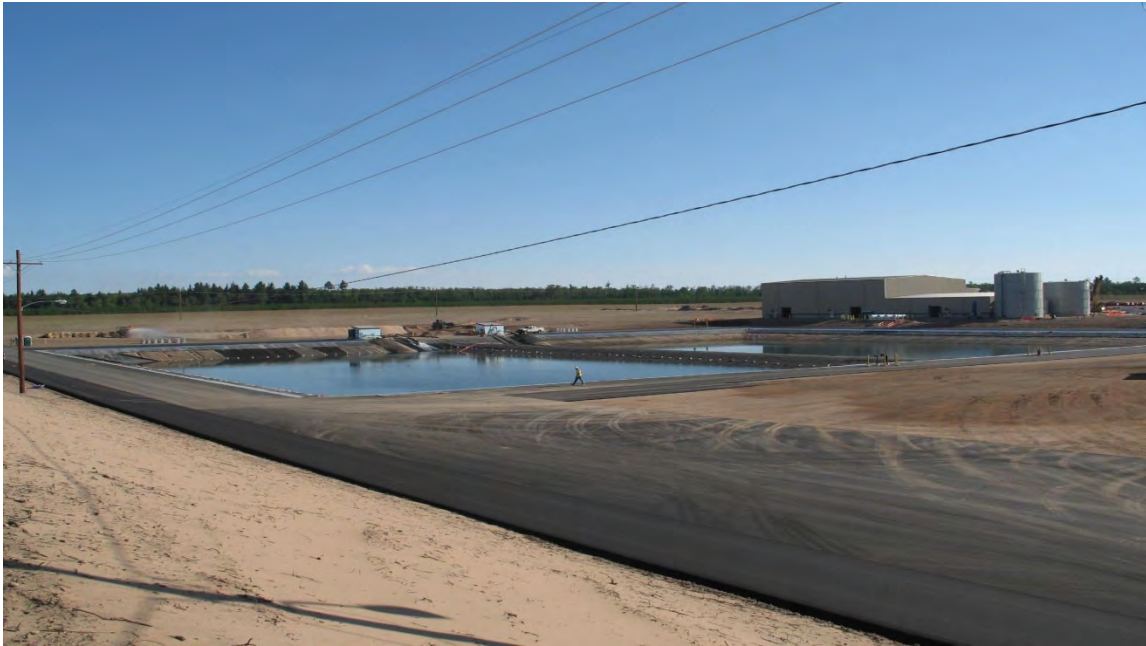
Currently, two areas within the storm water contact area remain to be constructed. The Coarse Ore Storage Building and Mine Substation footprints remain unpaved until construction of the facilities during the summer of 2012. In order to ensure contact area snow is not plowed into those footprints, and that storm water runoff cannot discharge to the open area, reflective posts and curbing have been installed surrounding the footprints of the buildings.

Contact Area Paving Underway, August 2011

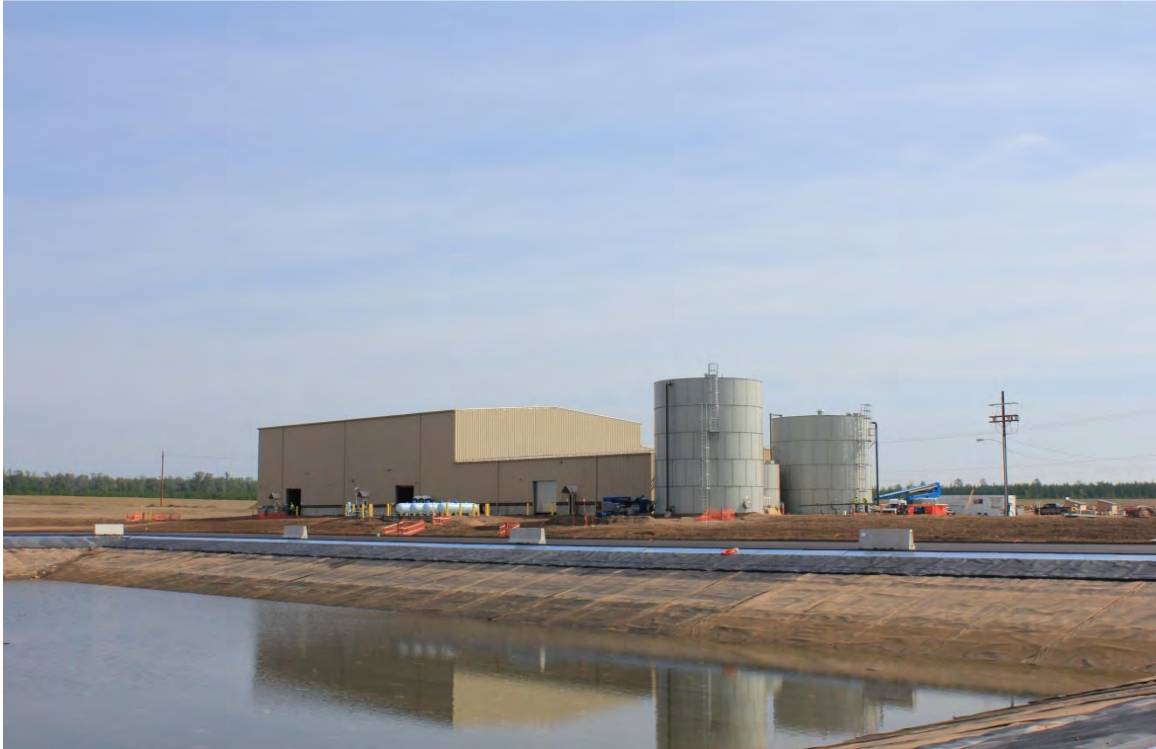
In June 2010, final WTP designs were submitted to MDEQ for review, and approval was received on July 7, 2010. Construction of the WTP commenced following the August 18, 2010 amendment approval for relocation. Commissioning began in August 2011 and first the first discharge of treated water to the Treated Water Infiltration System (TWIS) occurred on October 9, 2011. All documents and information required per the State of Michigan issued Groundwater Discharge Permit (GW1810162) were submitted, and if applicable, approved by MDEQ.

Water Treatment Plant, September 2011

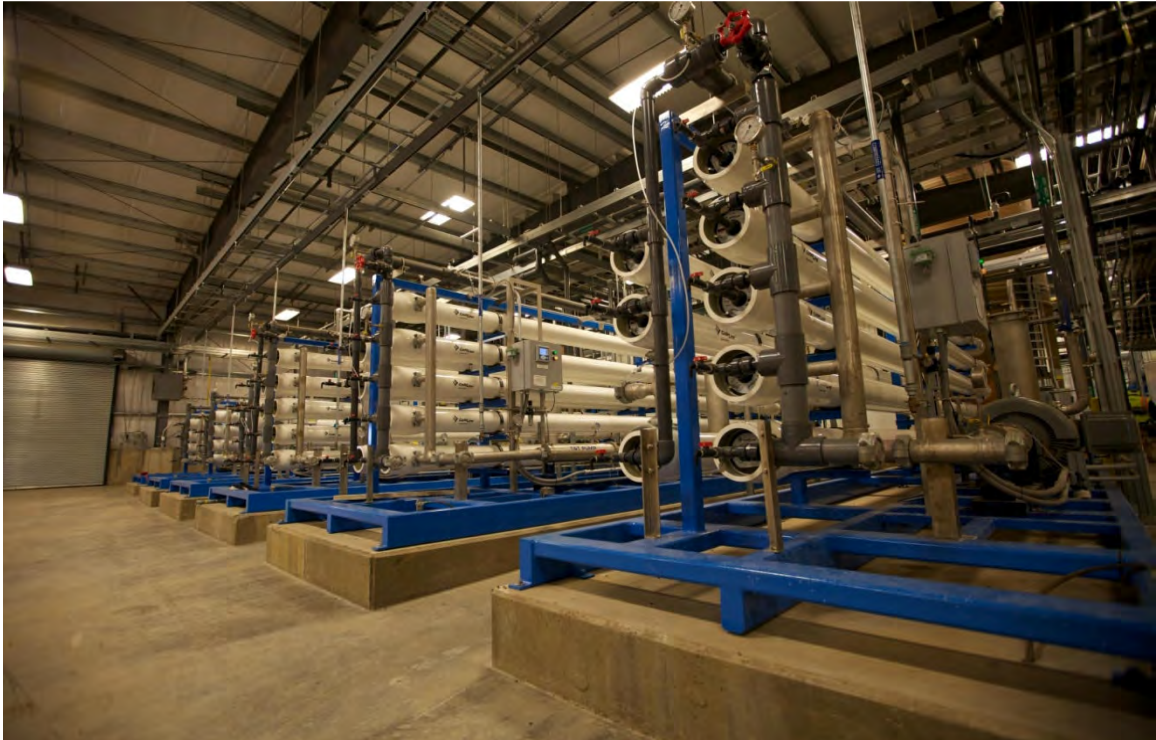
Reverse Osmosis Units in WTP, 2011

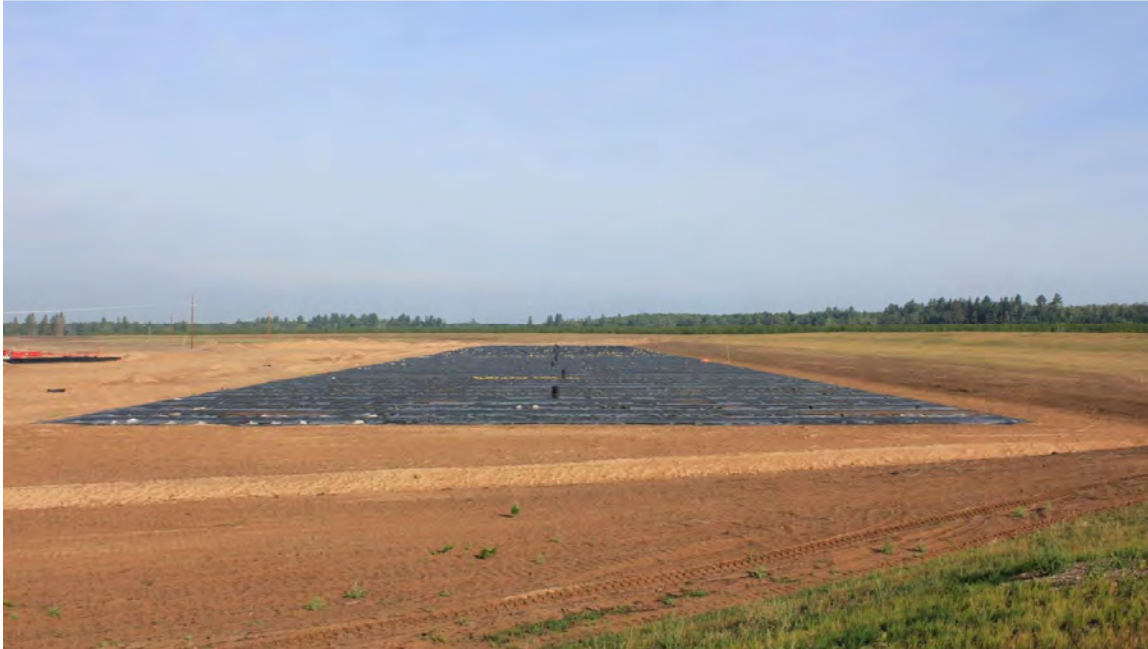
Construction of the TWIS began in September 2010 and was completed during the 2011 construction season. KEMC received a final Construction Quality Assurance (CQA) report in November 2011 that is available upon request.

Treated Water Infiltration System (TWIS), September 2011

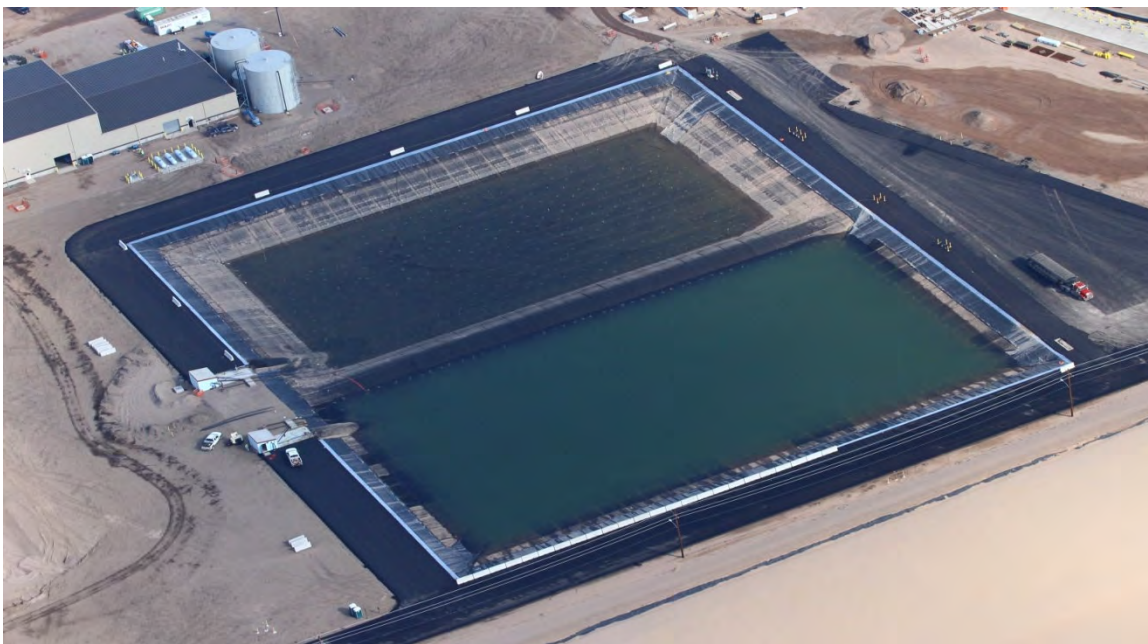
Construction of the CWBs began in 2010, leak detection tests on the welded seam membrane liner were completed in May 2011, and the Construction Quality Assurance (CQA) certification report was approved by MDEQ on September 14, 2011.

Contact Water Basins, September 2011

During the 2012 construction season, aerators will be installed to minimize ice formation, provide mixing for better WTP operations, prevent excessive sediment deposition, and assist in optimizing water quality before treatment from the underground operations.

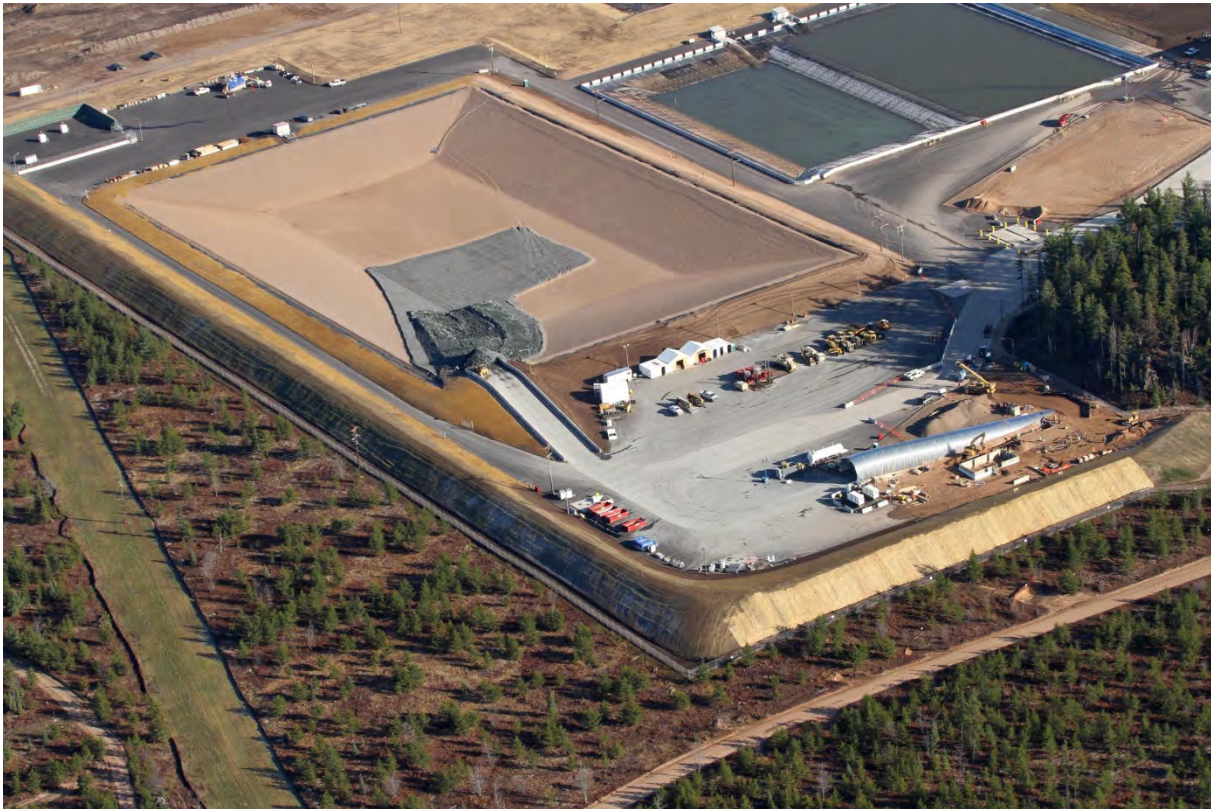
The TDRSA is designed to safely store rock produced from the decline and other underground development until it can be returned to the underground as backfill. Permanent construction of the TDRSA began following MDEQ approval of the final liner design which was received on September 3, 2010.

Prior to the installation of the secondary liner, also known as the leak detection sump, density tests were performed on the compacted sub-base to ensure a solid foundation. Following the liner installation, a leak location survey was performed and completed in September/October 2010. The risers, pumping system and primary liner were then installed and leak tested in October/November 2010. The final CQA certification report for the primary and secondary liner systems was submitted to MDEQ August 16, 2011 and approved on September 14, 2011. Prior to any placement of development rock on the TDRSA, MDEQ inspected the final grading of the sand layer.

Temporary Development Rock Storage Area (TDRSA), November 2011

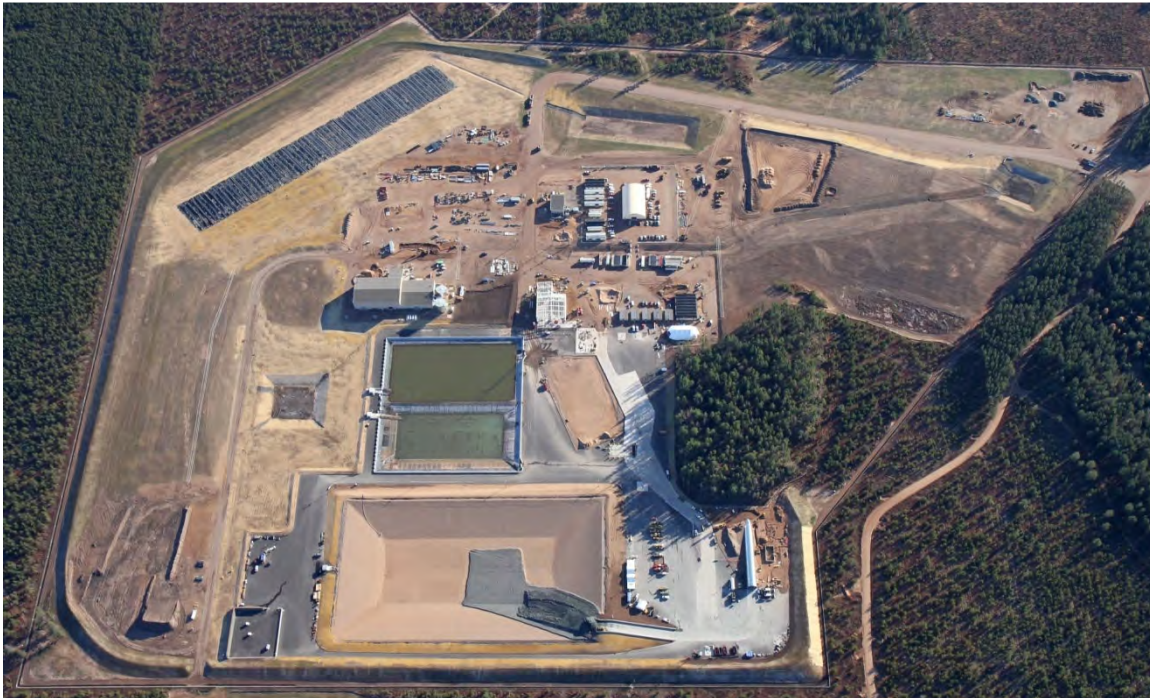
Eagle Mine Site Aerial View, November 2011

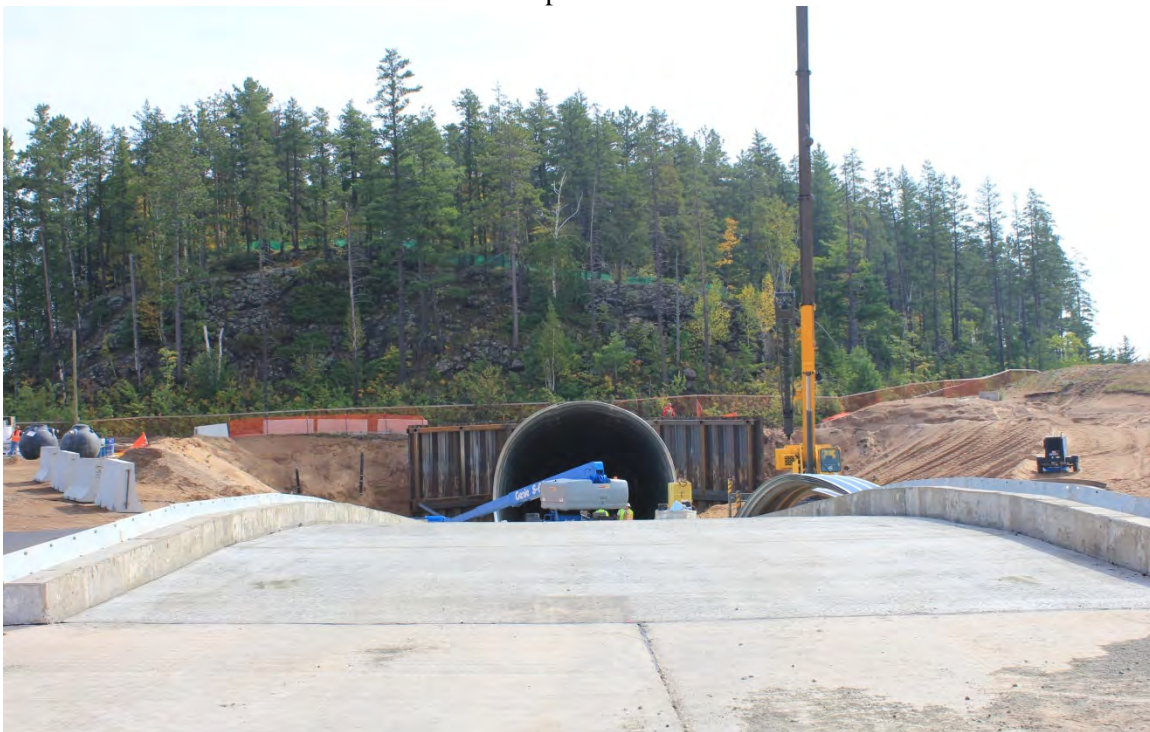
Prior to the start of drilling, the mine entrance, or portal, was constructed. The portal measures approximately 78 meters in length and is constructed of reinforced steel. This was extended from the original plan of 37 meters in order to enter the bedrock further below grade and provide additional assurance of no disturbance of the rock outcrop found within Exhibit G of the Surface Use Lease.

Portal Construction, August 2011

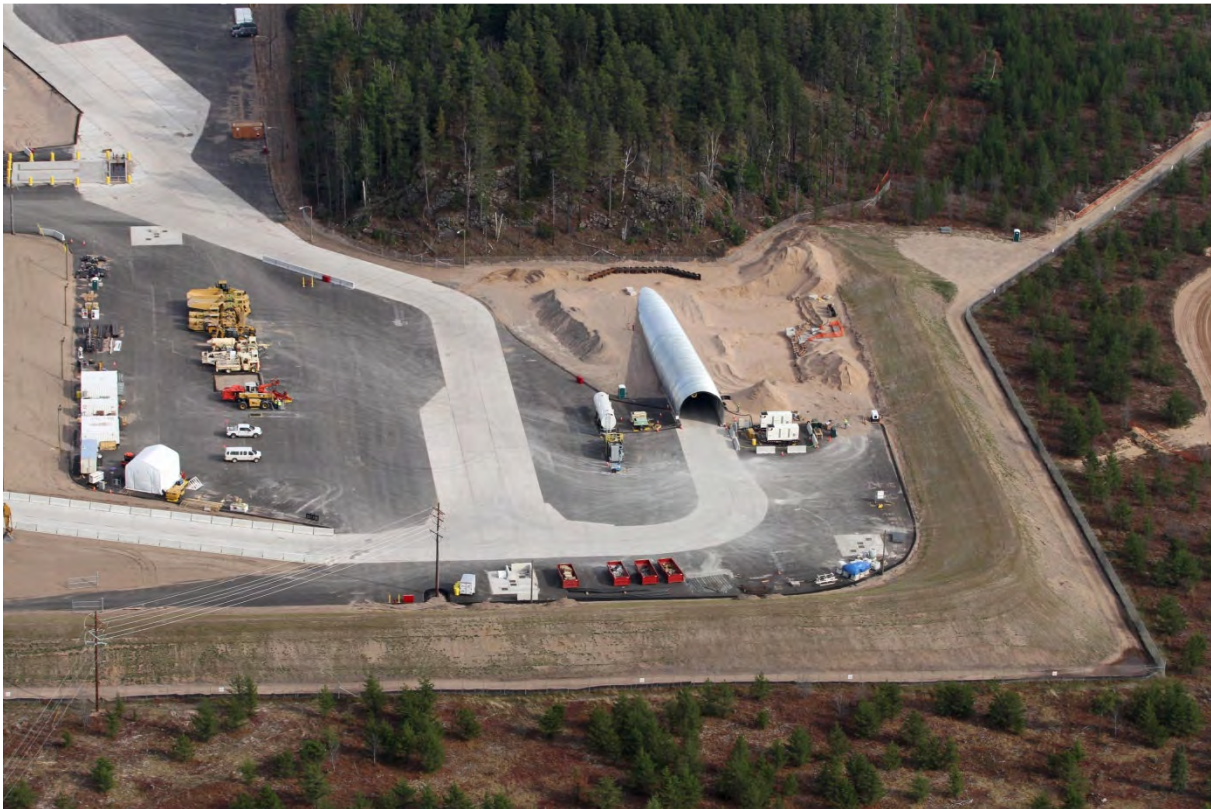
As of December 31, 2011, mining of the primary decline had progressed a total of approximately 230 meters (excluding the 78 meter portal). The primary decline is arch shaped and measures approximately 5.5 meters wide by 5.3 meters high. Table 3.1 below summarizes the monthly progress

Steel Arch Complete, 2011
